**Flood Control Project Maintenance
Levee Inspections****LMA District Cover Sheet****Spring 2015 Levee Inspection Results****Sacramento Maintenance Yard Sacramento Bypass**

Levee Inspection Report By Mile - Spring 2015

Sacramento Maintenance Yard Sacramento Bypass

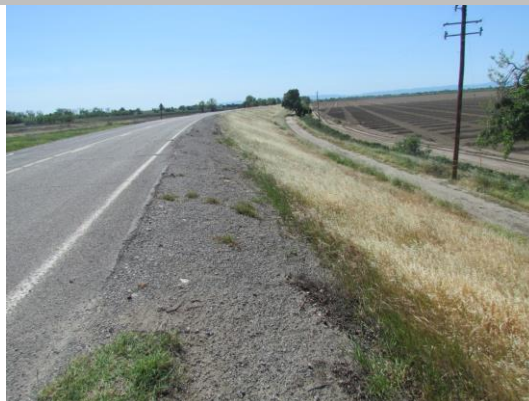
Photo 1 of 1 : SP_2015_ST0008_284_156_20150417_00002.jpg

LM Start	0.04	Rating **	M	Issue No.	156
LM End	1.73	Issue Type +	Ma	Location *	LS
Category	Earthen Levee			GPS Latitude/Longitude	
				Start	End
Item	Vegetation			38.606933 °	38.599515 °
				-121.560655 °	-121.590107 °
DWR ID	DWR_ST0008_01_s _ 2015_156				
Action/Comments					
Control annual grass and weeds on the levee slopes and easements.

View of the vegetation on the landward side of the levee looking downstream. Spring 2015.

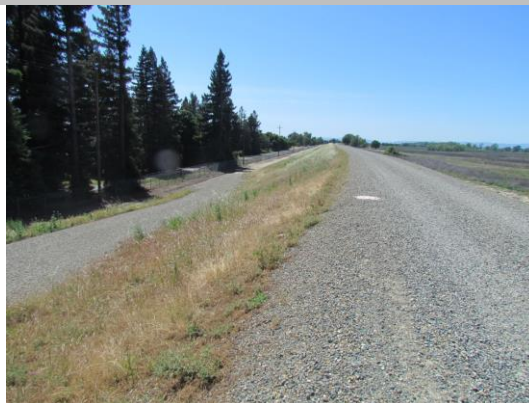
Photo 1 of 1 : SP_2015_ST0008_285_2_20150417_00003.jpg

LM Start	0.08	Rating **	M	Issue No.	2
LM End	1.78	Issue Type +	Ma	Location *	LS
Category	Earthen Levee			GPS Latitude/Longitude	
				Start	End
Item	Vegetation			38.602432 °	38.594620 °
				-121.556945 °	-121.586702 °
DWR ID	DWR_ST0008_02_s _ 2015_2				
Action/Comments					
Control annual grass and weeds on the levee slopes and easements.

View of the vegetation on the landward side of the levee looking downstream. Spring 2015.

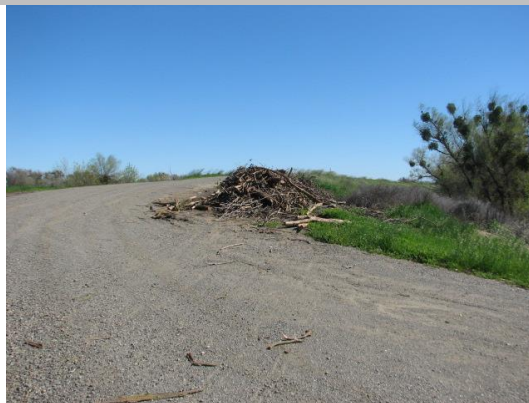
Photo 1 of 2 : SP_2015_ST0008_285_5_20150401_00001.jpg

LM Start	1.77	Rating **	M	Issue No.	5
LM End	1.77	Issue Type +	En	Location *	LS
Category	Earthen Levee			GPS Latitude/Longitude	
				Start	End
Item	Encroachments			38.594777 °	38.594777 °
				-121.586525 °	-121.586525 °
DWR ID	DWR_ST0008_02_f _ 2013_5				
Action/Comments					
Prunings					
Inspector Comments: This is a seasonal pile but gets burned by the maintenance division each year.

This is this years pile of brush and will be burned by the maintenance yard. Spring 2014

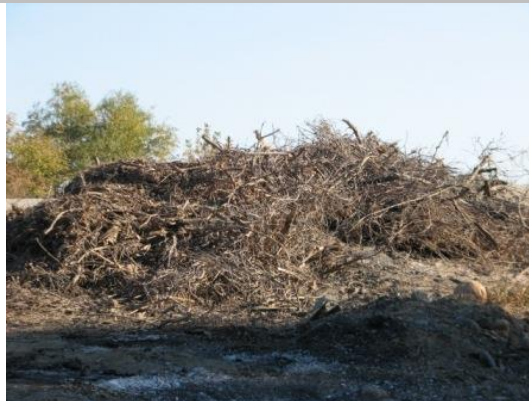
Photo 2 of 2 : SP_2015_ST0008_285_5_20150401_00002.jpg

LM Start	1.77	Rating **	M	Issue No.	5 (cont)	
LM End	1.77	Issue Type +	En	Location *	LS	
Category	Earthen Levee			GPS Latitude/Longitude		
				Start		End
Item	Encroachments			38.594777 °	38.594777 °	
				-121.586525 °	-121.586525 °	
DWR ID	DWR_ST0008_02_f_2013_5					
Action/Comments						
Prunings						
Inspector Comments: This is a seasonal pile but gets burned by the maintenance division each year.

The never ending pruning pile at the end of the unit. Fall 2013
